**Site Name:** Covitch Property / Former ATF Davidson Co.

Location: Northbridge, MA

**CERCLIS No.:** MAD046128559

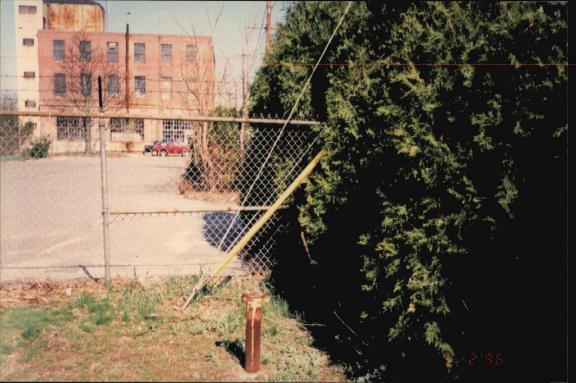
Photo: 1-1

**Description:** LD = Northwest; Monitoring Well MC-14 foreground

fire station in background.

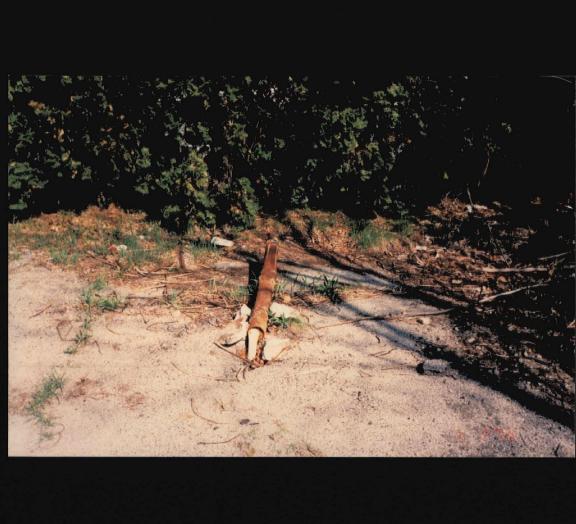
Legation: Northbridge MA Photo: 1-2

. **Description:** LD = Northwest; Monitoring Well MC-13, inoperable

due to snow plow damage.

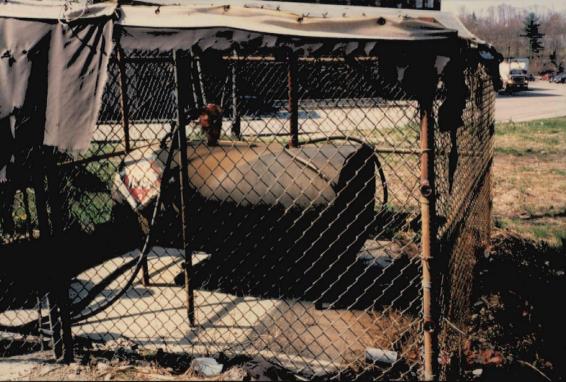
Location: Northbridge, MA Photo: 1-3

**Description:** LD = Southwest; 250-gallon diesel fuel aboveground

storage tank.

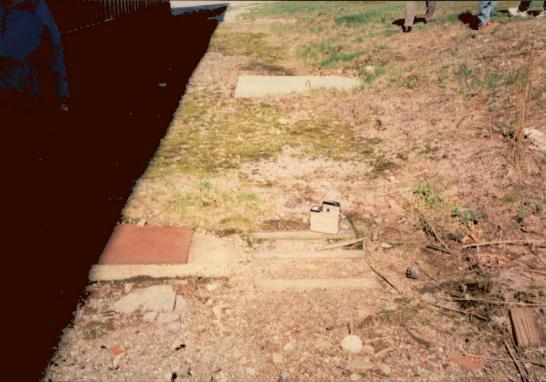
Photo: 1-4

**Description:** LD = Northwest; cover for former underground storage tank area along north side of Building No. 12.

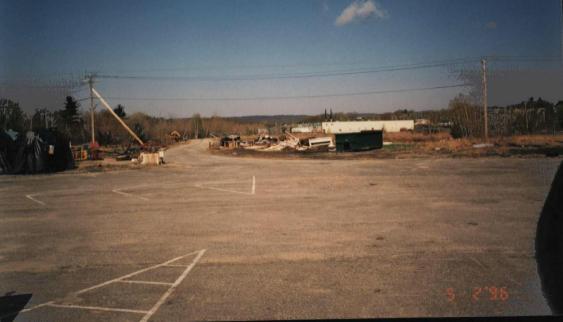
Location: Northbridge, MA Photo: 1-5

**Description:** LD = West; view from Covitch Property towards Arcade property showing rolloff, abandoned equipment, debris pile

and stained soil; Arcade building in background.

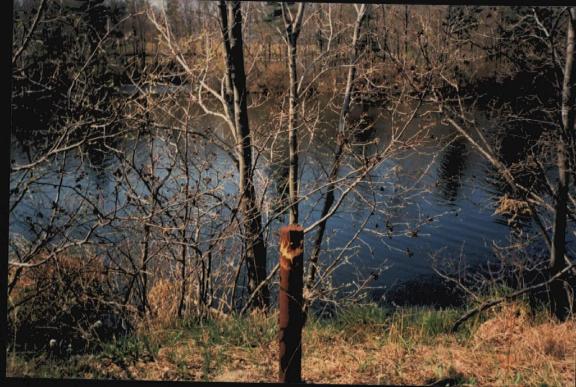
Location: Northbridge, MA Photo: 1-6

**Description:** LD = South; Monitoring Well MC-15, Mumford River

in background.

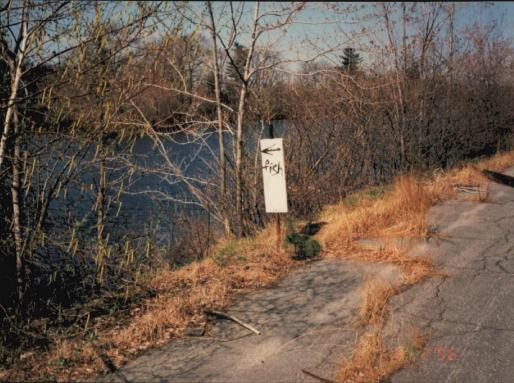
Location: Northbridge, MA Photo: 1-7

**Description:** LD = Southwest; view from Covitch Property of a sign

indicating that fishing occurs along Mumford River.

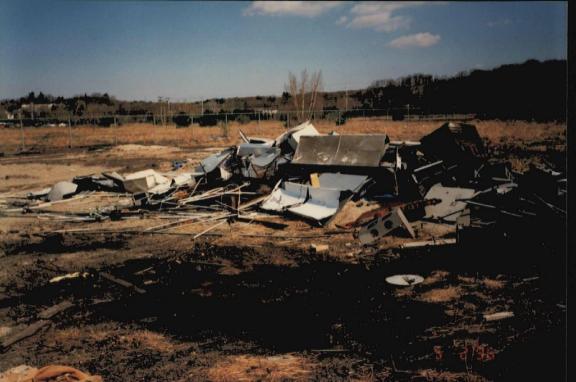
Location: Northbridge, MA Photo: 1-8

**Description:** LD = Northwest; debris pile and area of stained soil on the Covitch Property, west of Building 12, fence dividing Covitch and Arcade property in background.

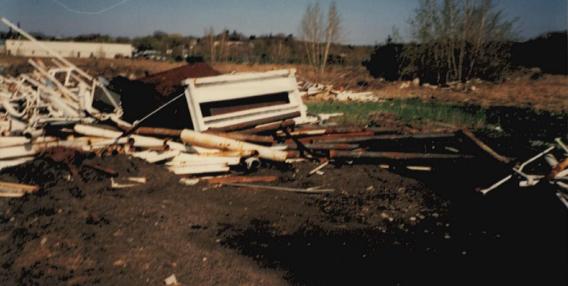
Location: Northbridge, MA Photo: 1-9

**Description:** LD = West; debris pile, stained coal ash-like material

area and dismantled storage tank west of Building No. 12.

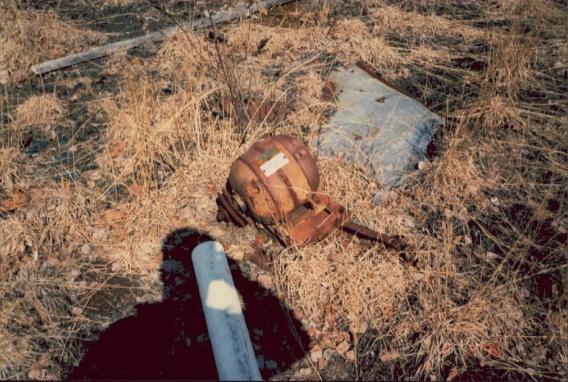
Location: Northbridge, MA Photo: 1-10

**Description:** LD = North; dismantled 2 horsepower/3 phase electric

mower on the Covitch property west of Building No. 12.

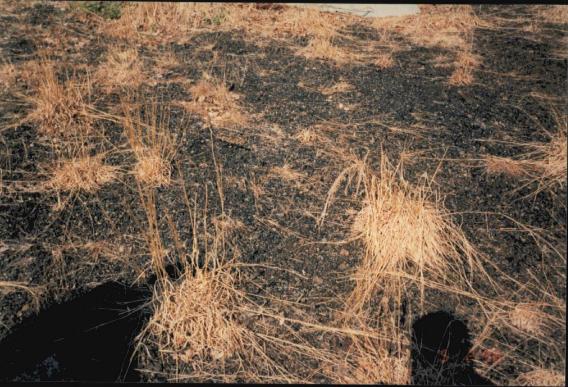
Photo: 1-11

**Description:** LD = Northwest; typical appearance of the "coal ashfoundry sand fill material" on the Covitch property west of Building No. 12.

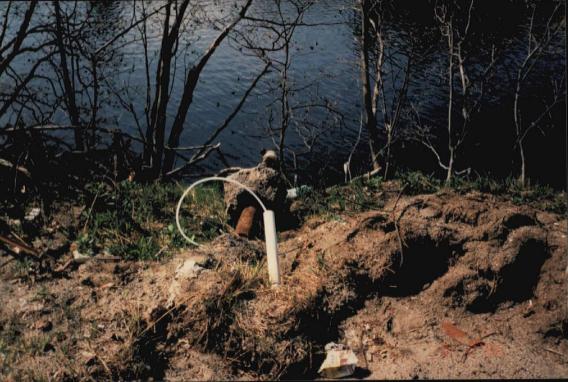
Time: 1000 **Description:** LD = Southeast; inoperable, Monitoring Well MC-12,

located along the west of Building No. 12.

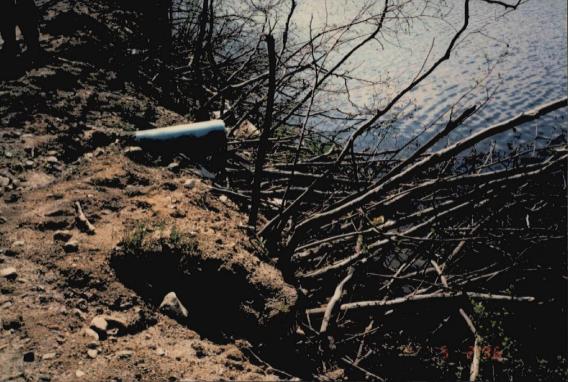
**Description:** LD = Southeast; inoperable Monitoring Well MC-11 (concrete seal and well casings), and a plastic discharge pipe to the

Mumford River.

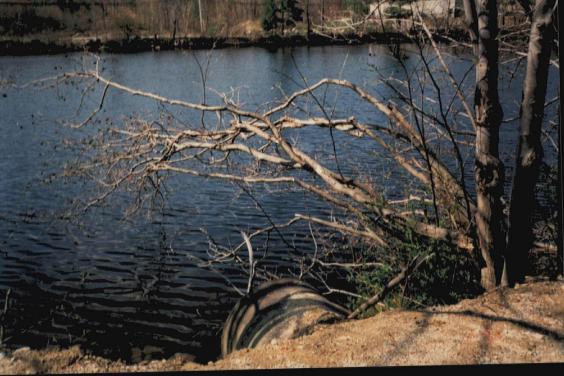
Location: Northbridge, MA Photo: 1-14

**Description:** LD = South; unknown concrete discharge pipe to the

Mumford River, south of Covitch Building No. 12.

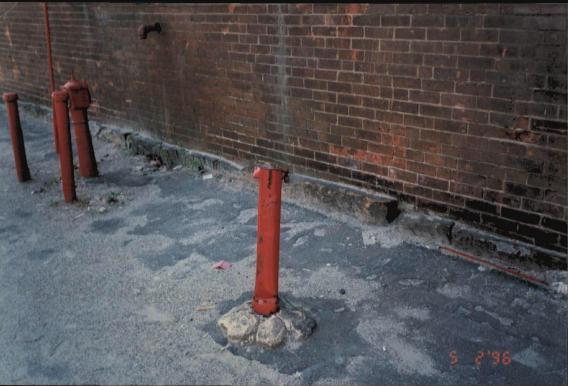
Date: 2 May 1996 Time: 1014 **Description:** LD = South; Monitoring Well MC-10, note minor

snowplow damage to well cement casing, north side of Covitch

Building No. 23 in background.

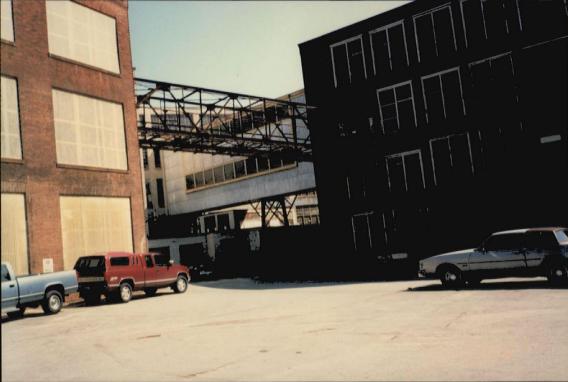
**Description:** LD = Northeast; view of parking area within courtyard, looking at Covitch Buildings No. 9, 10, and 11 in background.

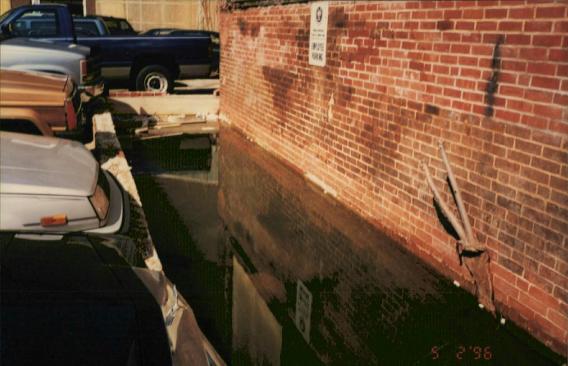
**Description:** LD = Northwest; view of former storage tank area (with ponded storm water), along south side of Covitch Building No.

11.

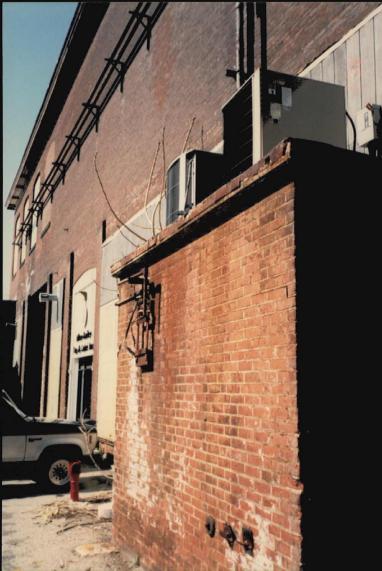
Location: Northbridge, MA Photo: 1-18

**Description:** LD = North; former electrical transformer area with connections visible along east side of Covitch Building No. 12.

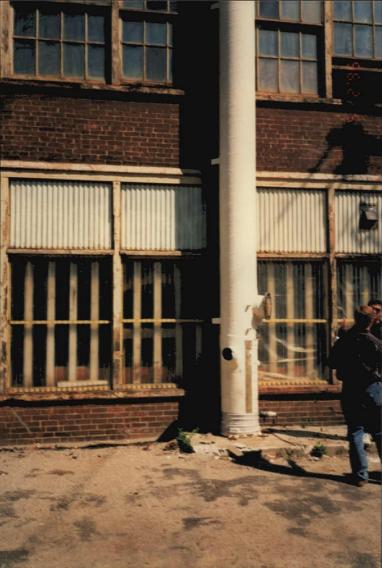
**Description:** LD = North; former air stripping column for the inactive pump and treat groundwater remediation system. Located

along south side of Covitch Building No. 9.

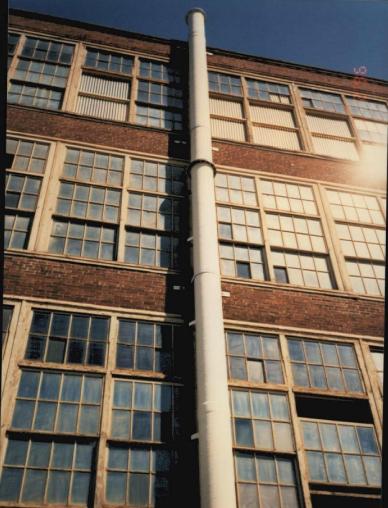
**Description:** LD = Northeast; former air stripping column mounted

to Covitch Building No. 9.

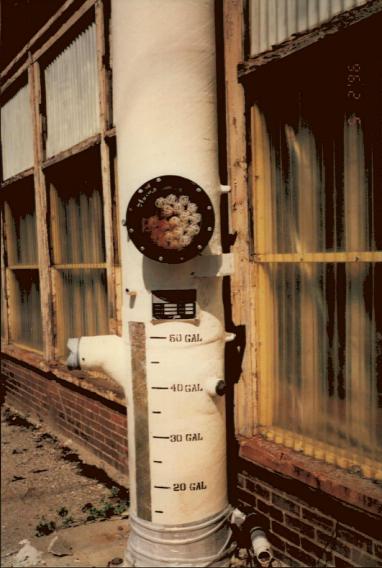
**Description:** LD = Northeast; close-up view of air stripping column mounted to Covitch Building No. 9.

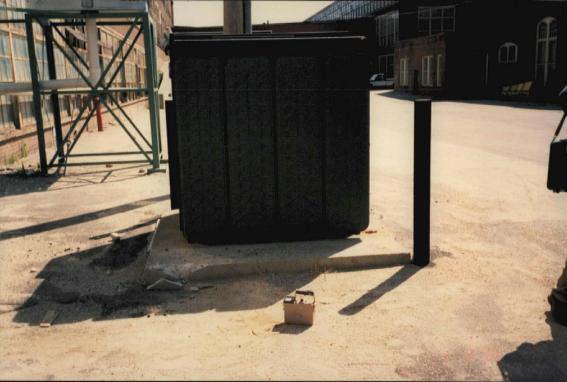
Location: Northbridge, MA Photo: 1-22

**Description:** LD = Southeast; observation well for pump and treat

system in raceway area; Covitch Building No. 9 to the left.

Transformer in background.

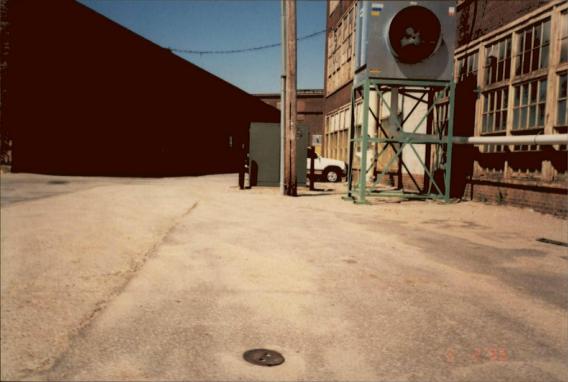
Location: Northbridge, MA **Photo:** 1-23

**Description:** LD = Northwest; observation well for pump and treat system, in raceway area; Covitch Building No. 9 to the right of the

transformer in background.

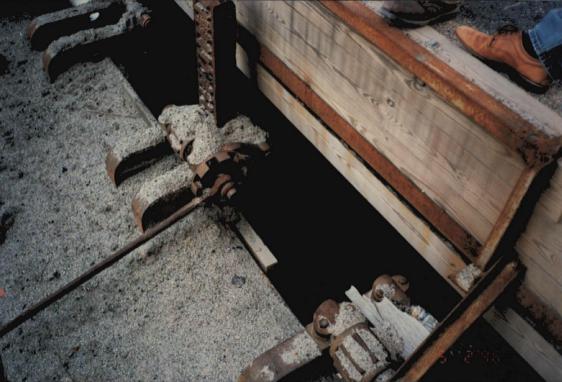
Date: 2 May 1996 Time: 1030
Description: LD = Northeast; lock mechanism for Raceway

headwater diversion channel between Covitch Building No. 19 and

10.

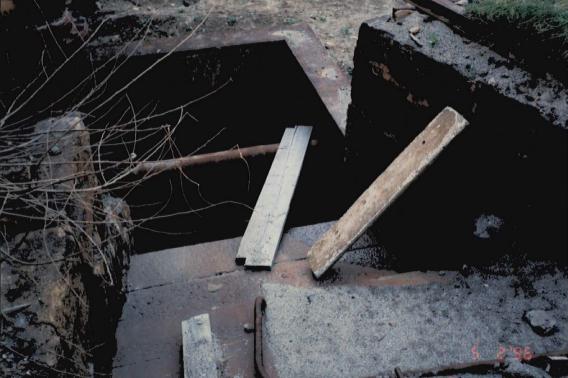
Location: Northbridge, MA Photo: 1-25

**Description:** LD = Northeast; lock mechanism for Raceway headwater diversion channel between Covitch Building No. 19 and

16.

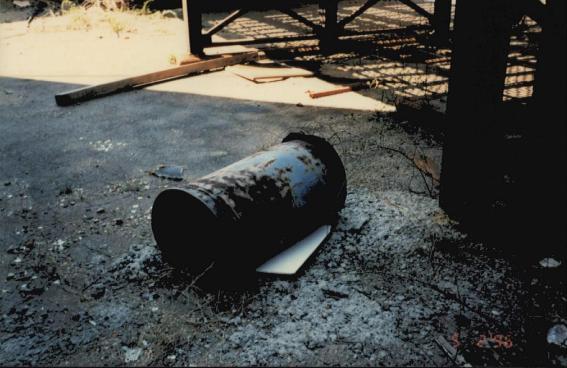
**Description:** LD = West; crushed drum below iron walkway,

adjacent to (east) Building No. 19.

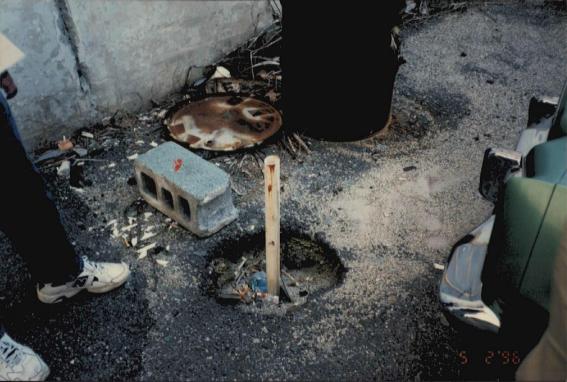
Description: LD = East; remnants of Monitoring Well MC-7

(inoperable); open 55-gal trash drum in background.
